**NASA  
Reference  
Publication  
1291**

# Fractography Handbook of Spaceflight Metals

Rebecca J. Derro

Rebecca J. Derro  
*Goddard Space Flight Center*  
*Greenbelt, Maryland*

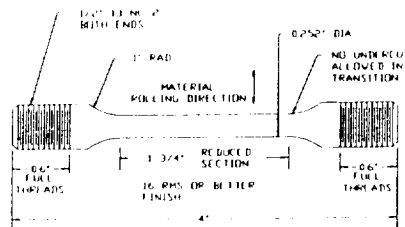
Figure 5-b. Smooth tensile overload specimen,  
4" long, 0.252" diameter

The dimensions for the smooth tensile overload specimens are shown in Figure 5-b, and the dimensions for the notched tensile overload specimens are shown in Figure 5-c. The compact tension specimen dimensions are shown in Figure 5-d.

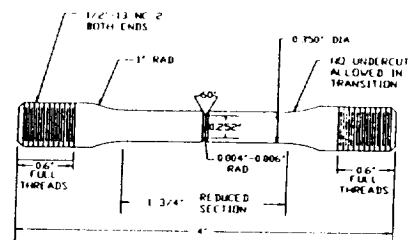
Figure 5-c. Notched tensile overload specimen,  
4" long, 0.004-0.006" root radius,  
0.252" notch diameter.

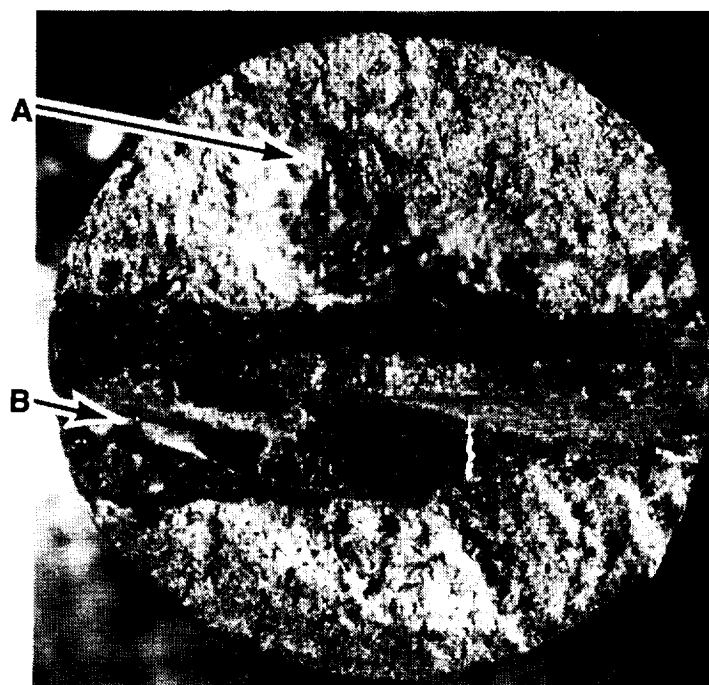
Fig. 5-3

Optical photomicrograph of fracture surface.

The fracture surface is shown in Figure 5-3. The surface is rough and uneven. The smooth area across the center of the specimen is a result of incomplete penetration of the weld and is not a fracture surface. The central portion is the nonwelded area.

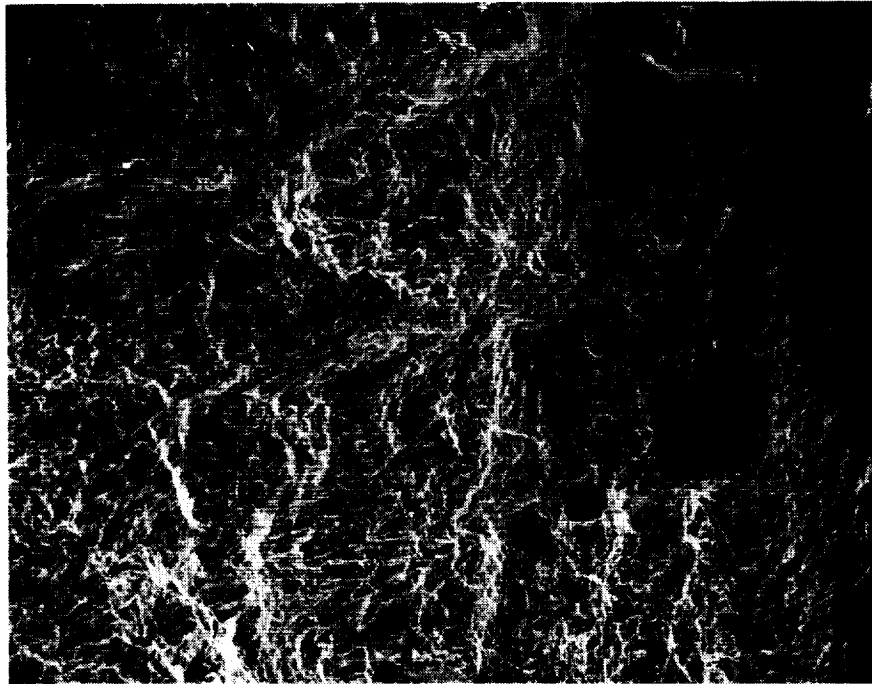
Fig. 5-4 40X  
Low magnification view of the different fracture morphologies.

Figures 5-4 to 5-7 Area A: This area is located on the left side of the fracture as shown in Figure 5-3. These microfractographs are representative of the welded metal. The fracture shows ductility at both low magnification and high magnification.

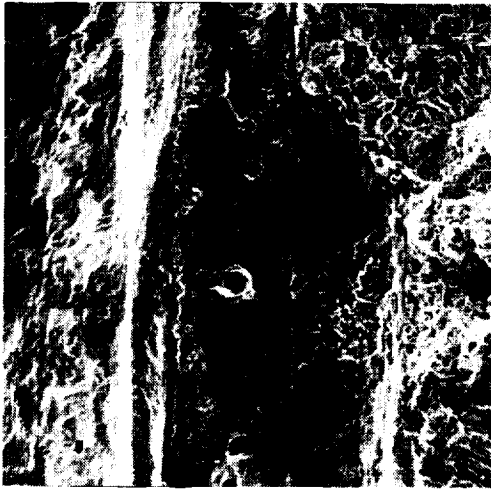
Fig. 5-5 160X  
Region A. Ductile fracture.

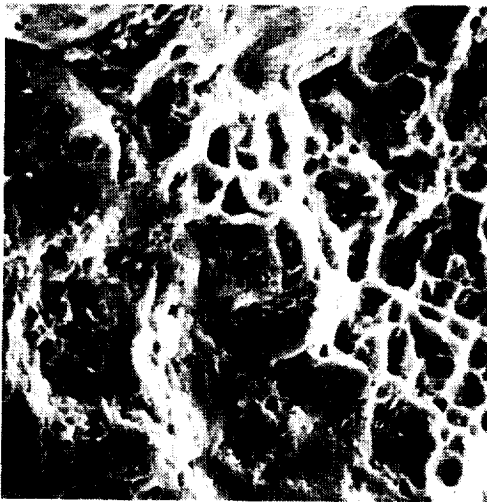
Fig. 5-6 640X  
Region A. Enlarged view of an area  
in the center of Fig. 5-5.

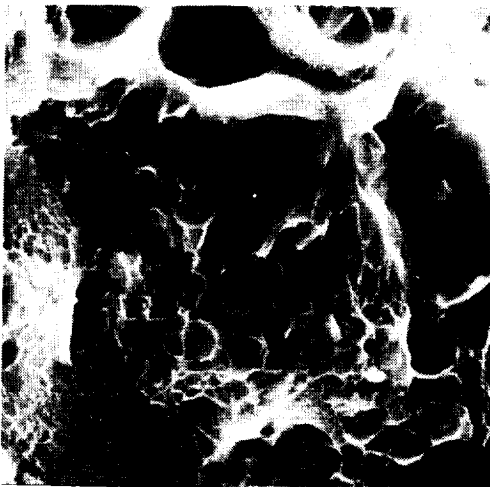
Fig. 5-7 2500X  
Region A. Center of Fig. 5-7.

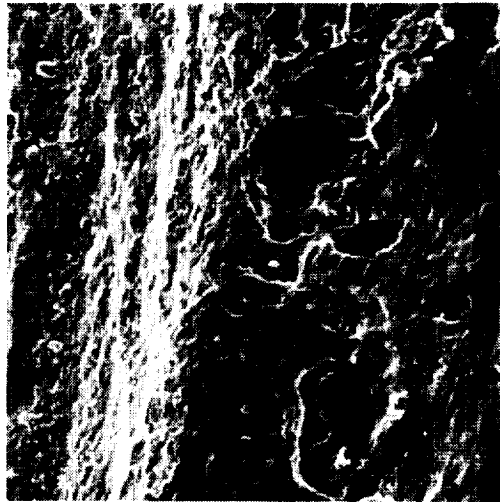
Fig. 5-8 160X  
Region B. Area showing lack of  
penetration.

Figure 5-8 to 5-9 Area B: This area is representative of the lack of fusion of the weld which is not a fracture surface.

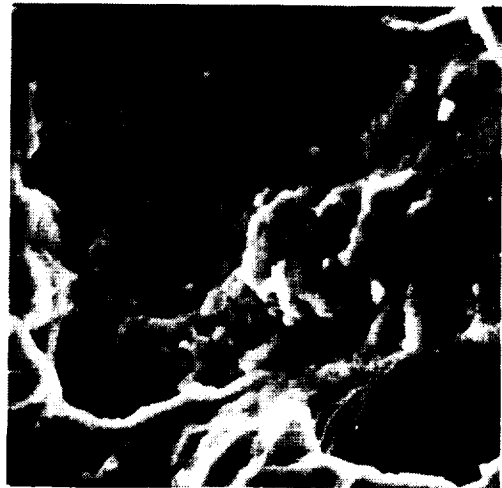
Fig. 5-9 640X  
Region B. Center of Fig. 5-8.

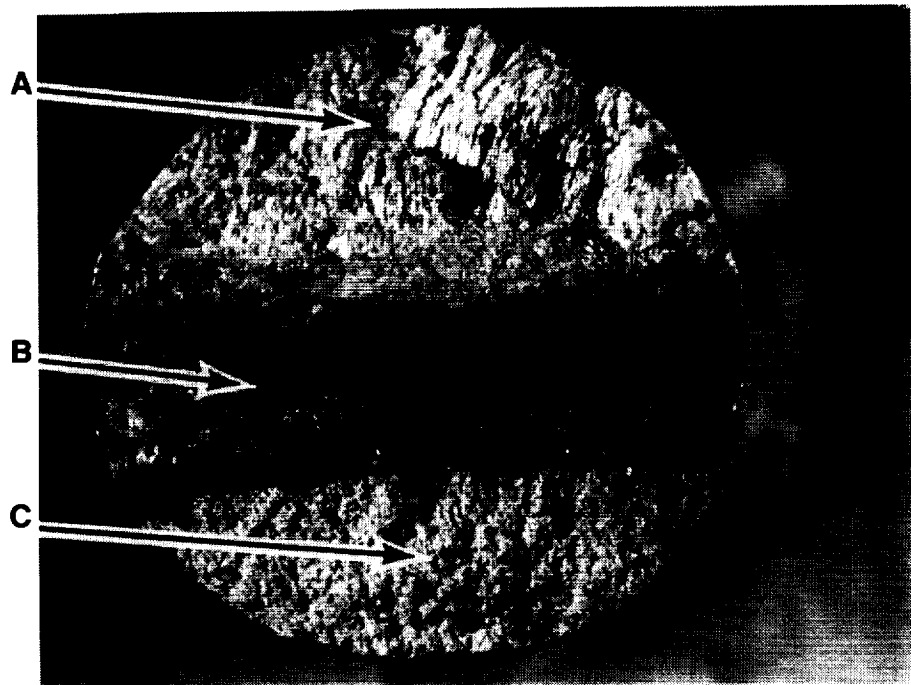
Fig. 5-10  
Optical photomicrograph of fracture surface.

The fractograph in Figure 5-10 shows that this fracture appears similar to the room temperature sample.

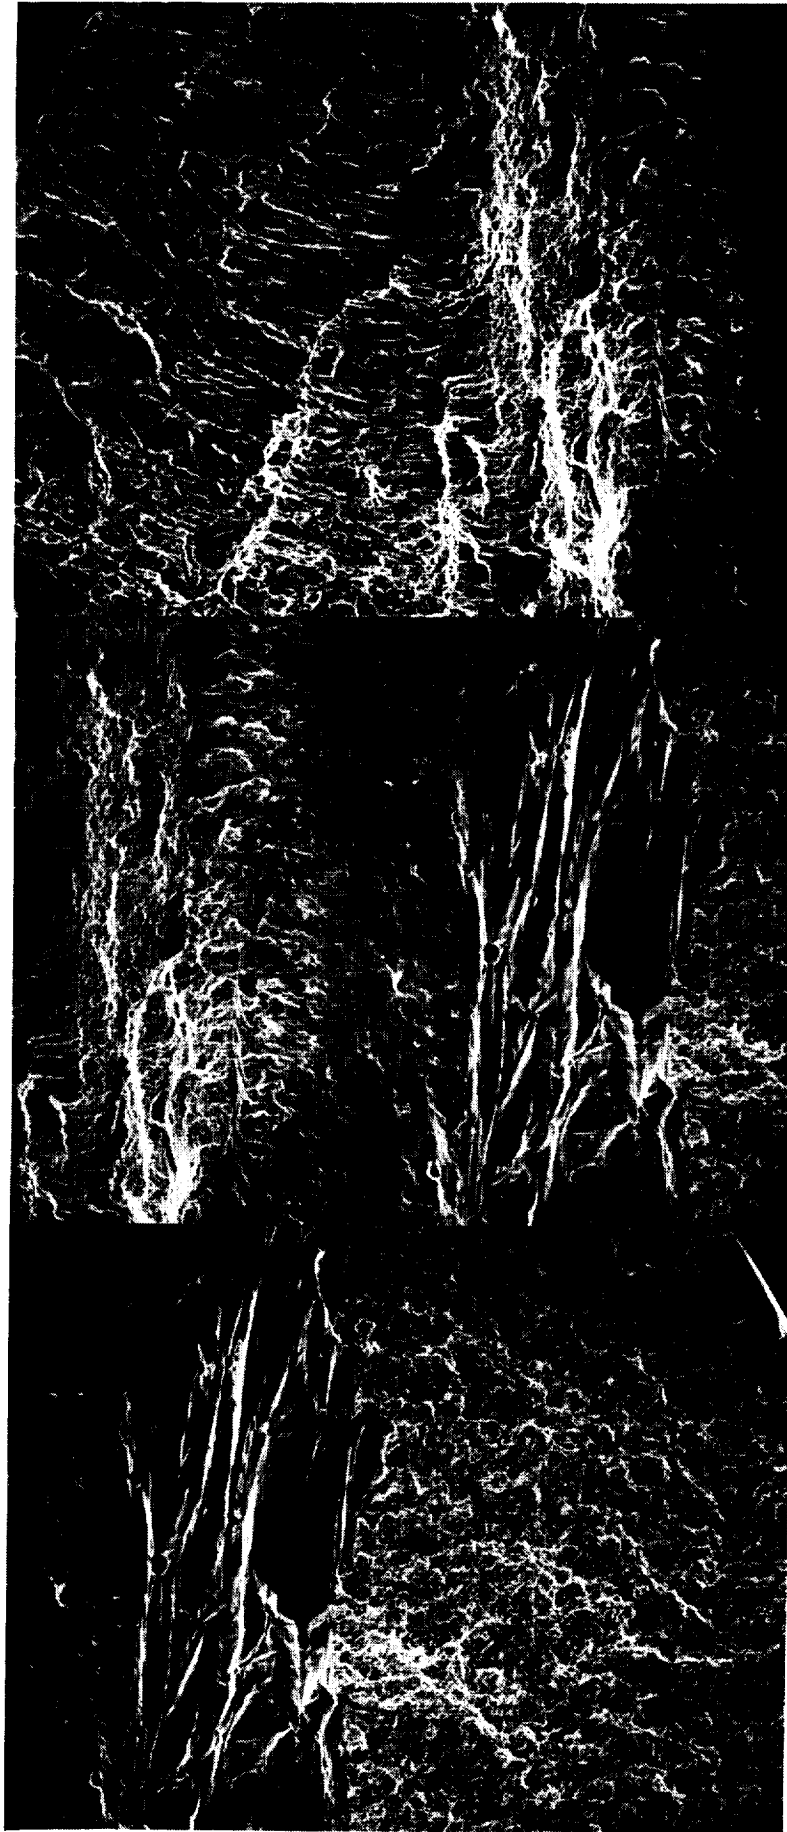
Fig. 5-11  
Low magnification fractograph showing several fracture morphologies. 40X

Figure 5-11 shows a SEM micrograph of the surface.

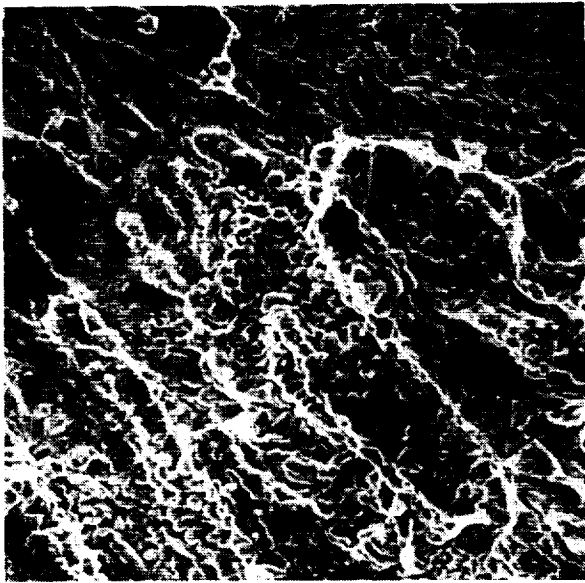
Fig. 5-12 160X  
Region A. Dendrites

Figure 5-12 to 5-15 Area A: These micrographs show dendrites in a porous weld area. This is the surface of a void area and is not a fracture surface.

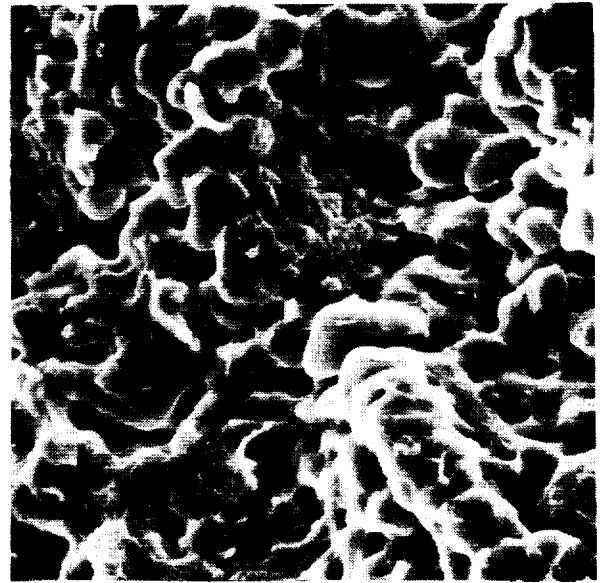
Fig. 5-13 640X  
Region A. Enlarged view of the center area  
in Fig. 5-12.

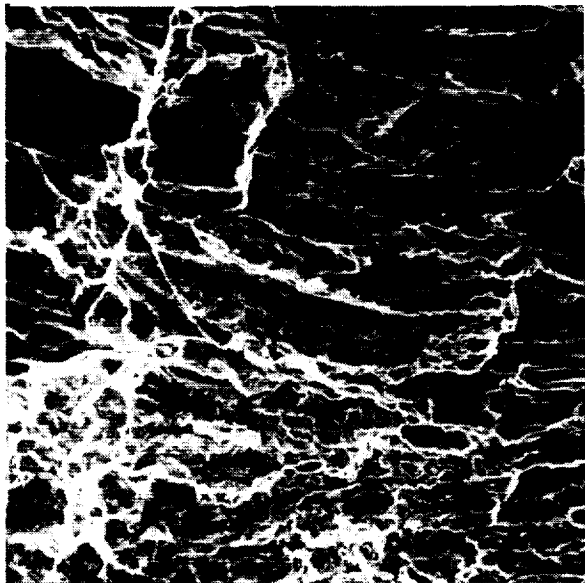
Fig. 5-14 160X  
Region A. Another area with dendrites.

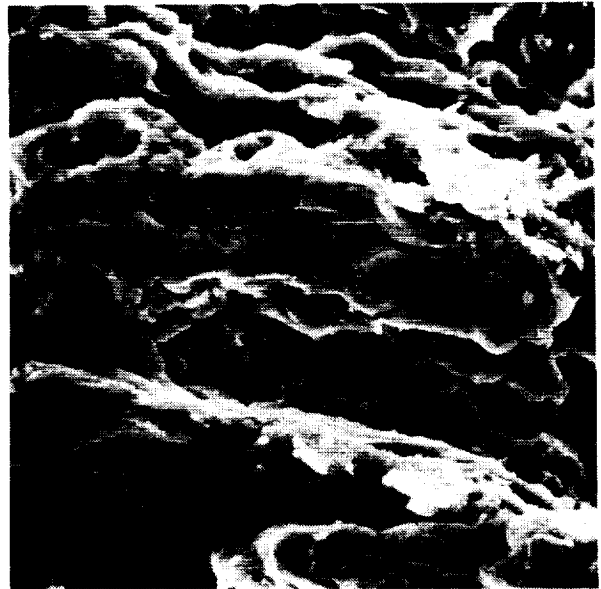
Fig. 5-15 640X  
Region A. An area in the center of Fig. 5-14.

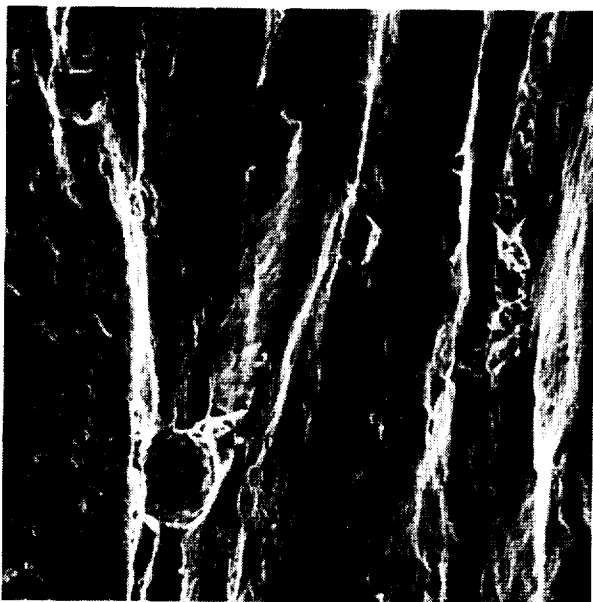
Fig. 5-16 160X  
Region B. Lack of penetration of the weld.

Figure 5-16 to 5-17 Area B: This area represents the incomplete penetration of the weld.

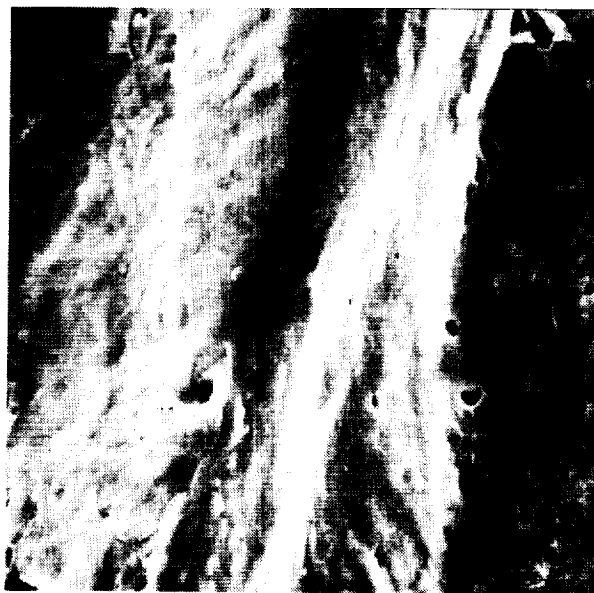
Fig. 5-17 640X  
Region B. Enlarged view of center of Fig. 5-16.

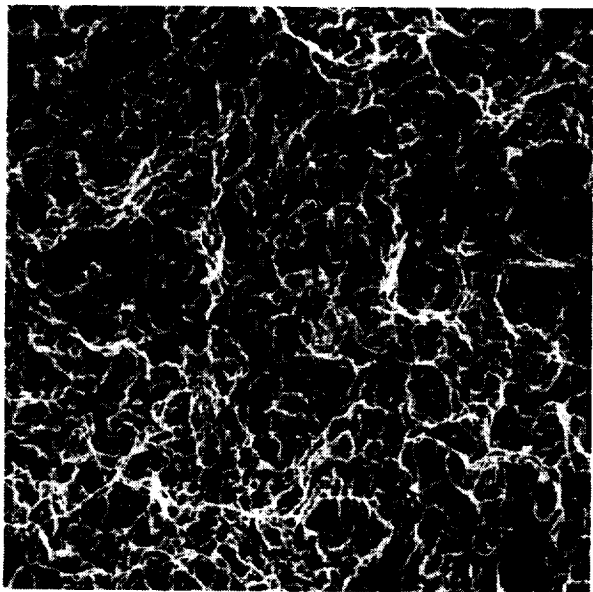
Fig. 5-18 160X  
Region C. Ductile dimples.

Figure 5-18 to 5-19 Area C: A region of ductile dimples.

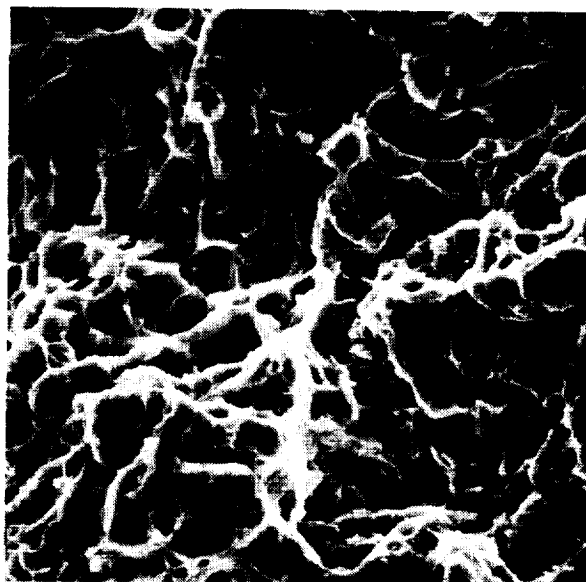
Fig. 5-19 640X  
Region C. Enlarged view of the center of Fig. 5-18.

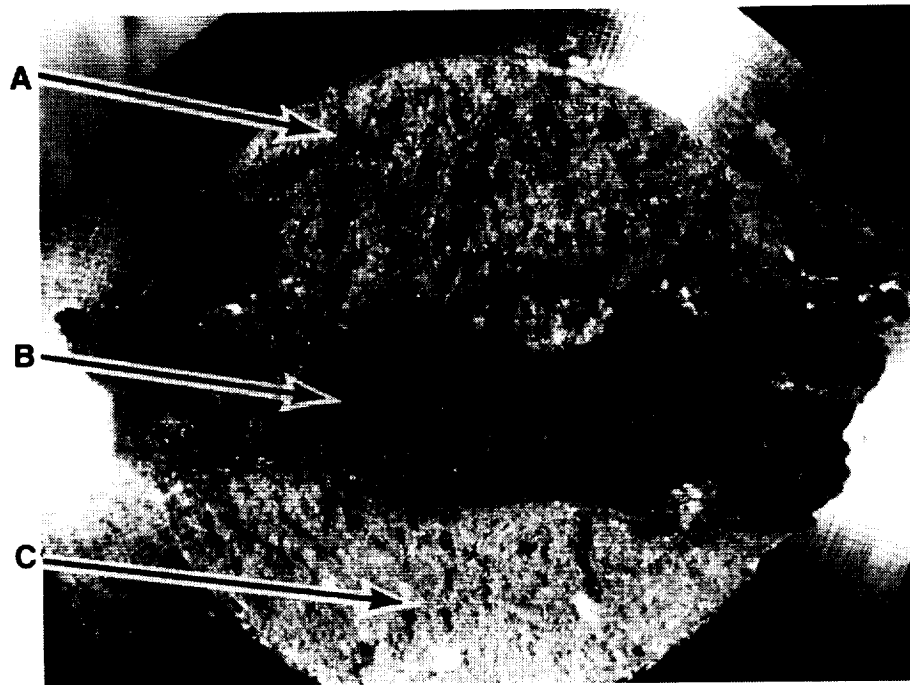
Fig. 5-20  
Optical photomicrograph of fracture surface.

Figure 5-20 shows the macrograph of this fracture surface.

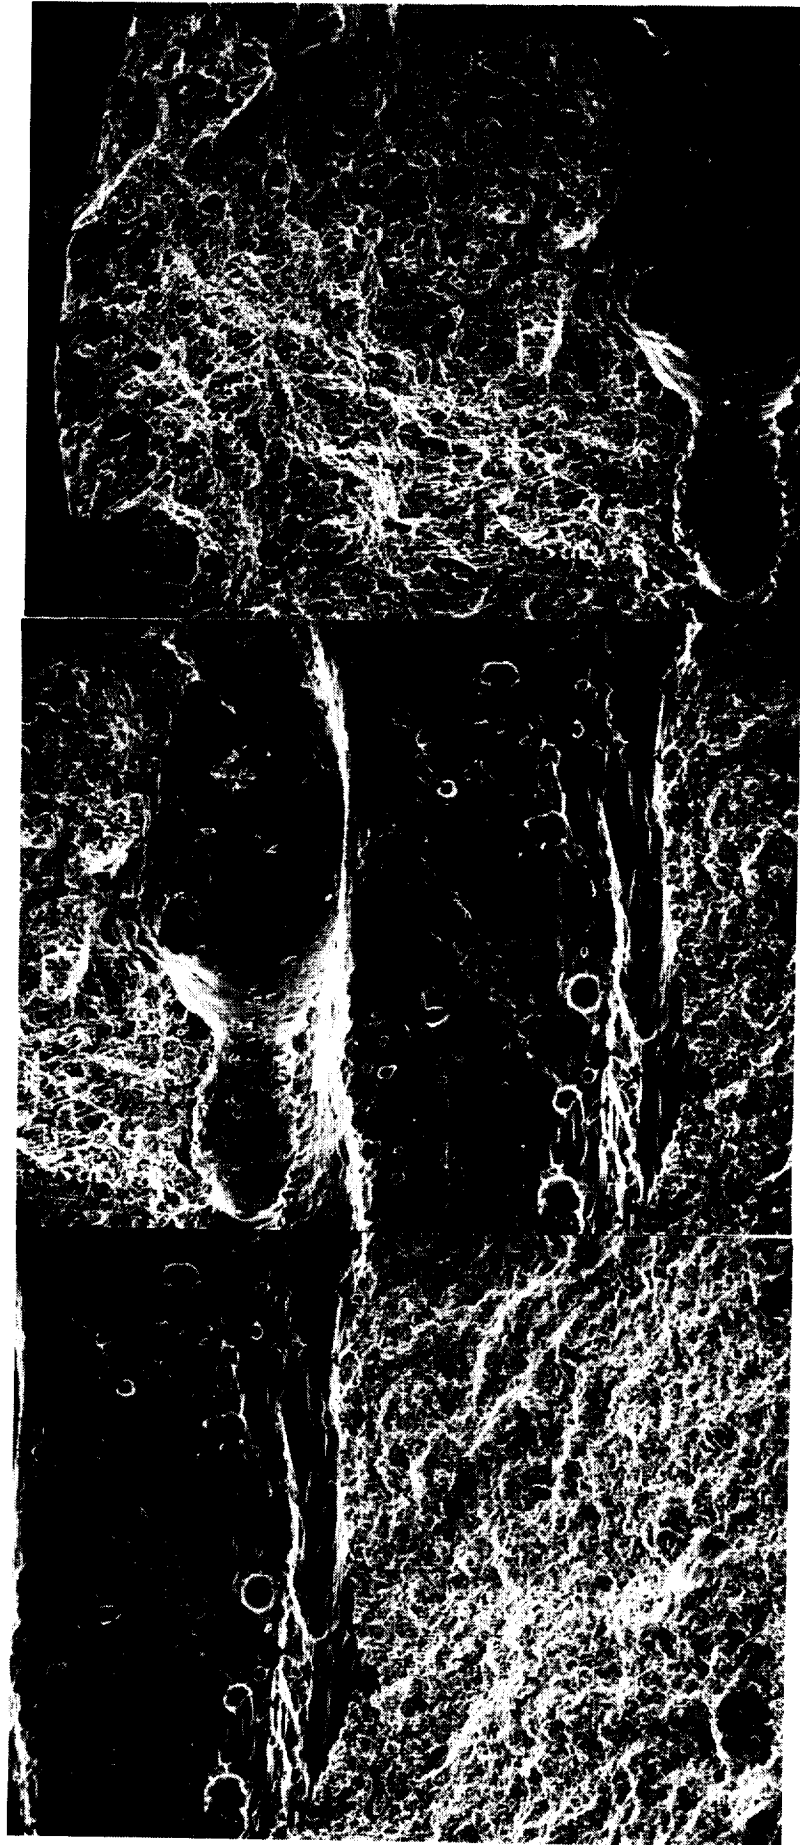
Fig. 5-21  
Low magnification fractograph showing several fracture morphologies. 40X

Figure 5-21 shows a low magnification SEM micrograph of the fracture surface.

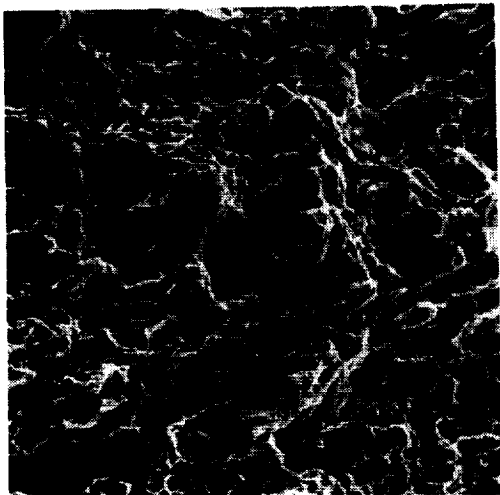
Fig. 5-22 160X  
Region A. Ductile dimples.

Figure 5-22 to 5-23 Area A: Fractographs showing the rough, dimpled fracture typical of this region.

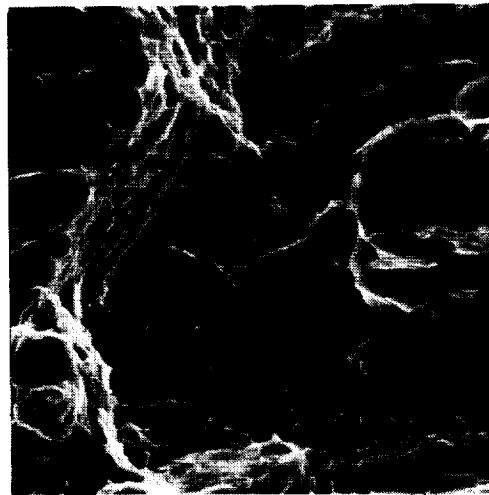
Fig. 5-23 640X  
Region A. Enlarged view of the center of Fig. 5-22.

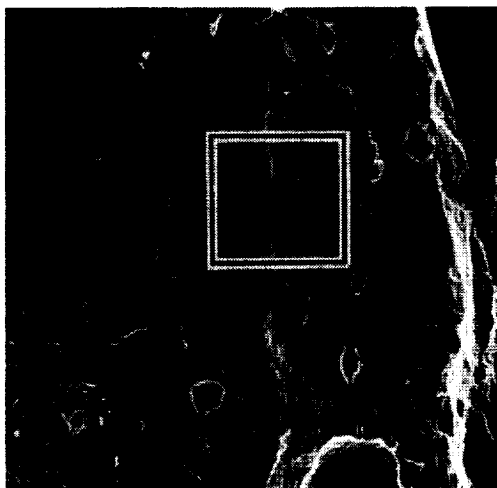
Fig. 5-24 160X  
Region B. Lack of penetration of the weld.

Figure 5-24 to 5-25 Area B: Fractographs showing the smooth nearly featureless unwelded area.

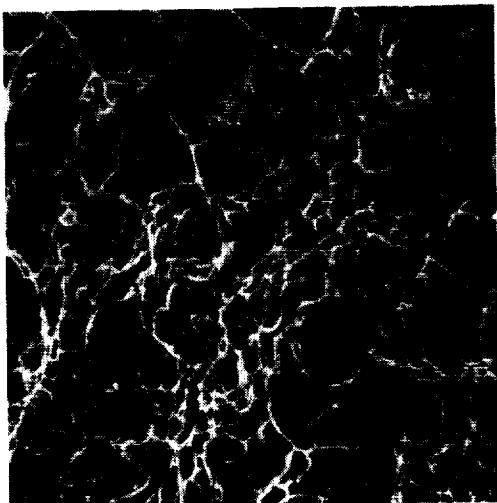
Fig. 5-26 320X  
Region C. Ductile dimples.

Figure 5-26 to 5-27 Area C: Fractographs showing the equiaxed dimples typical of this region.

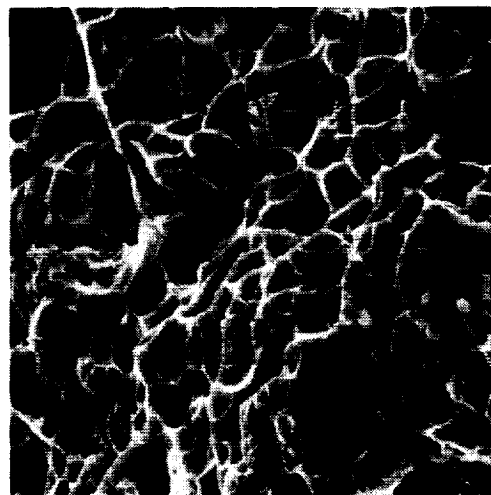
Fig. 5-27 640X  
Region C. Enlarged view of the center of Fig. 5-27.

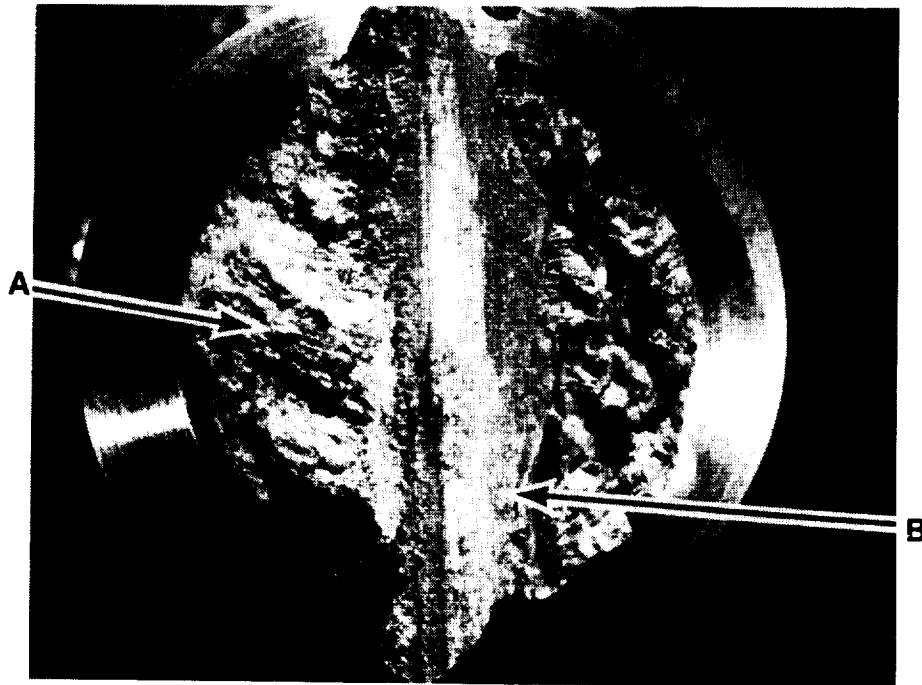
Fig. 5-28  
Optical photomicrograph of the fracture surface.

An optical picture of the fracture is shown in Figure 5-28.

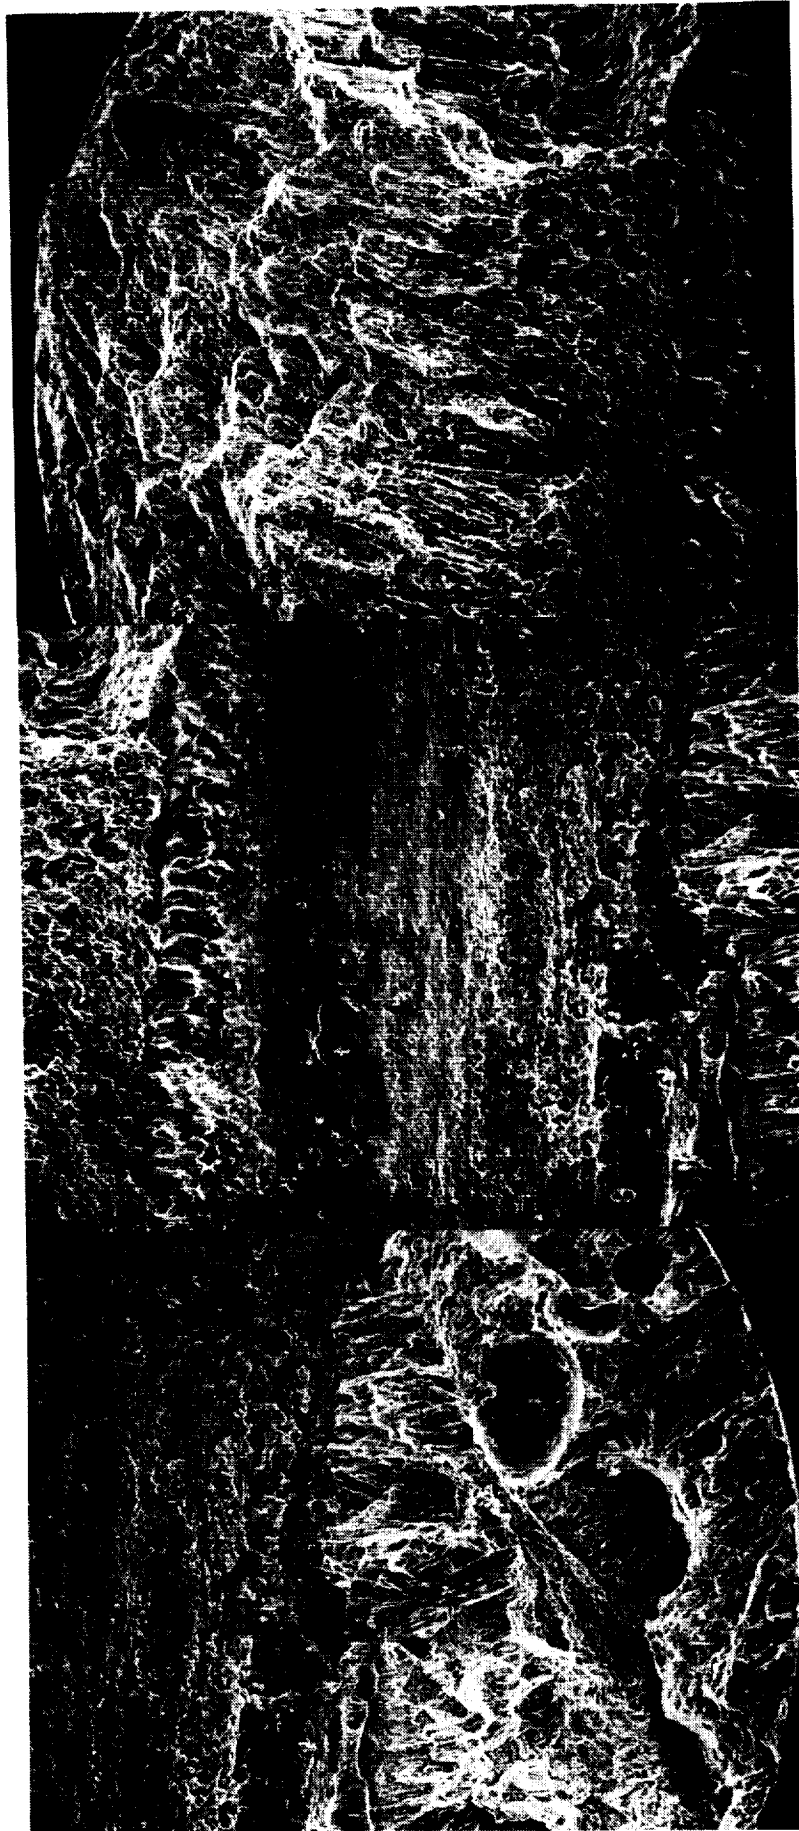
Fig. 5-29  
Low magnification fractograph of the different fracture morphologies.

Figure 5-29 shows a SEM micrograph of the fracture.

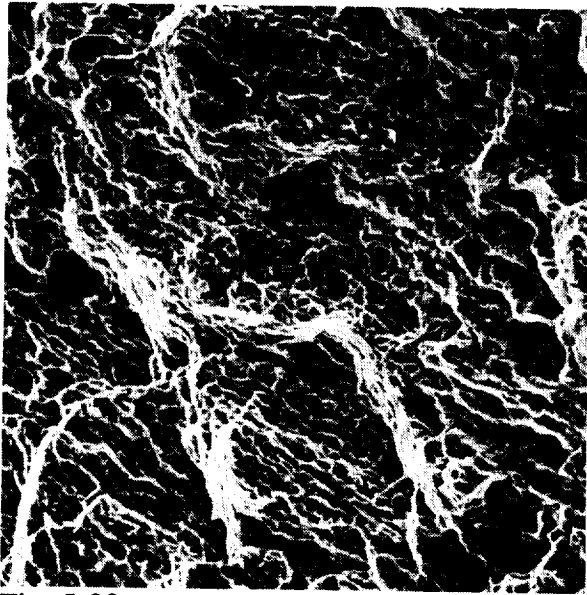
Fig. 5-30  
Region A. Ductile dimples. 160X

Figure 5-30 to 5-33 Area A: This area shows a rough and dimpled fracture surface in Figures 5-30 to 5-31. Dendritic formation in void areas is also evident in this area as shown in Figures 5-32 and 5-33.

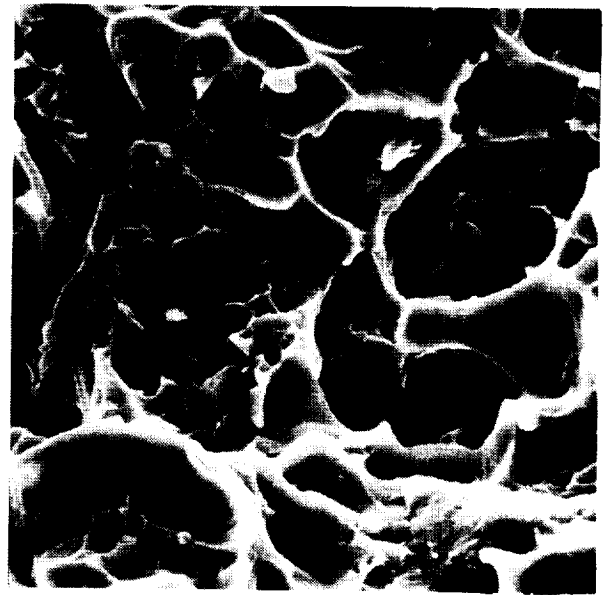
Fig. 5-31  
Region A. Enlarged view of the center of Fig. 5-30. 1250X

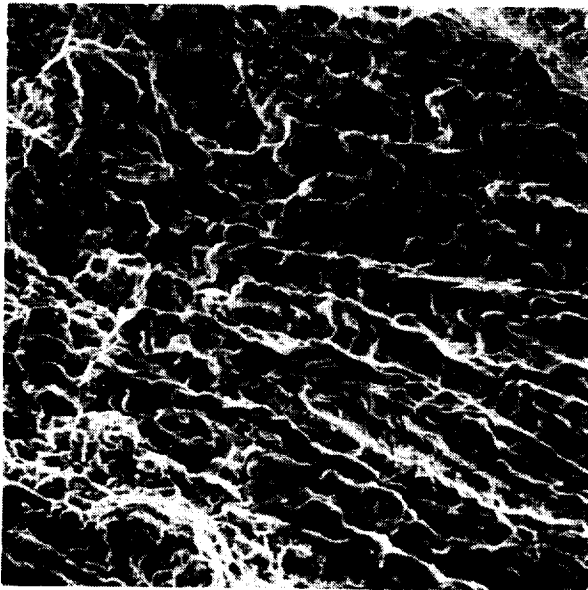
Fig. 5-32  
Region A. Area to the right of the dimples in area A. Dendrites. 160X

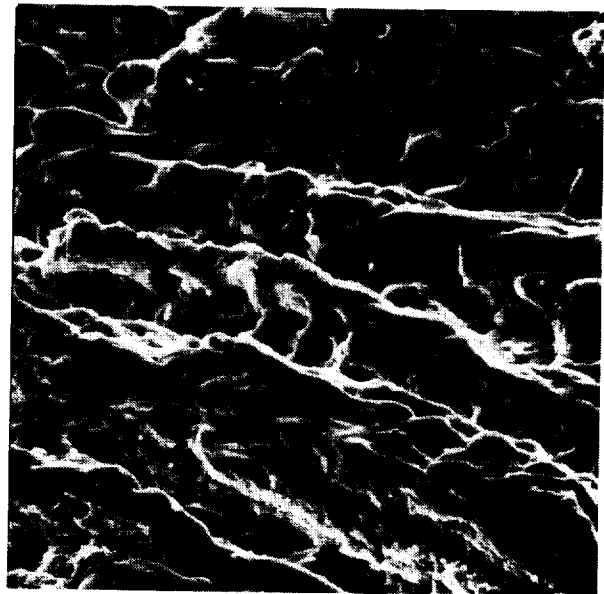
Fig 5-33  
Region A. Enlarged view of the dendrites in Fig. 5-32. 320X

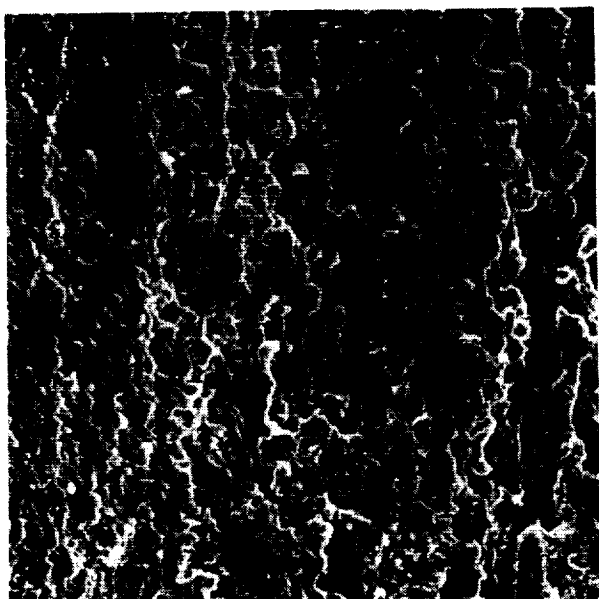
Fig 5-34 160X  
Region B. Lack of penetration of the weld.

Figure 5-34 to 5-35 Area B: These micrographs show the smooth features of the non-welded area resulting from incomplete penetration.

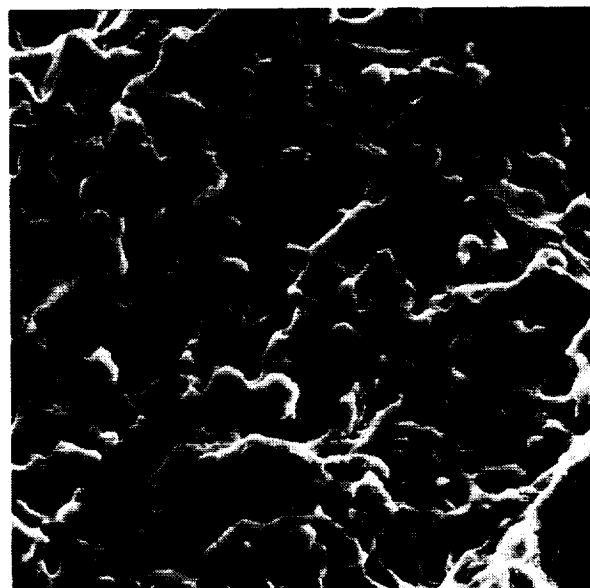
Fig. 5-37 320X  
Region C. Enlarged view of the center of Fig. 5-36.

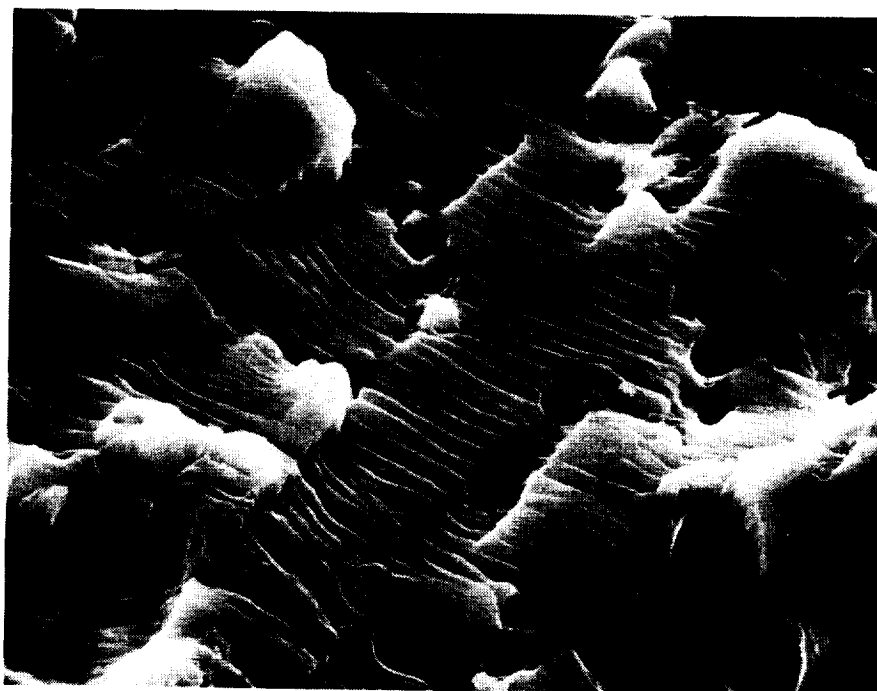
Fig. 5-38  
Optical photomicrograph of fatigue fracture surface.

Two of the fatigue regions are identified in the optical photograph in Figure 5-36. Regions 2 and 3 were documented using the SEM. Regions 1 and 4 are the precrack and fast fracture regions respectively and were not documented with fractographs. The loading data for these regions is displayed in the following chart:

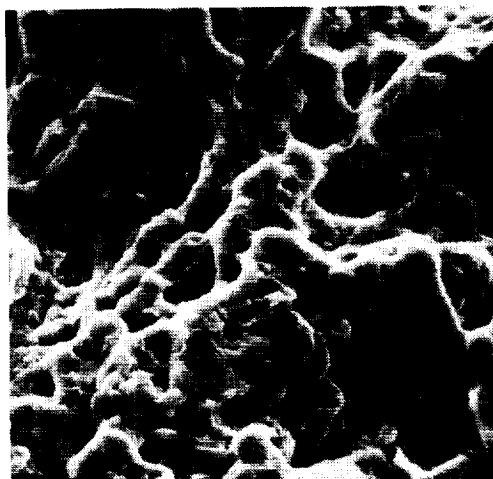
Fig. 5-40 2500X  
Region 2.

Figures 5-37 to 5-39 Region 2: The striations are clearly evident under these load conditions. Note the inclusions in the fracture surface.

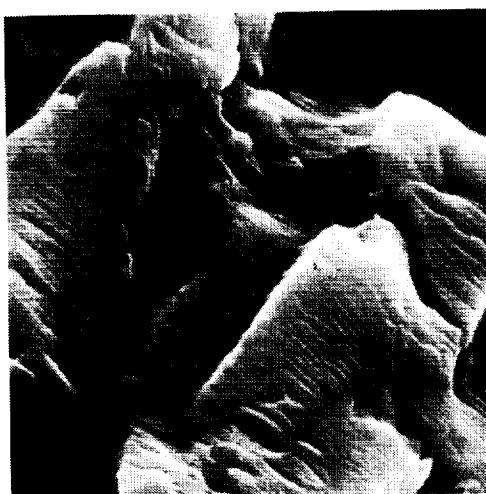
Fig. 5-41 10000X  
Region 2.

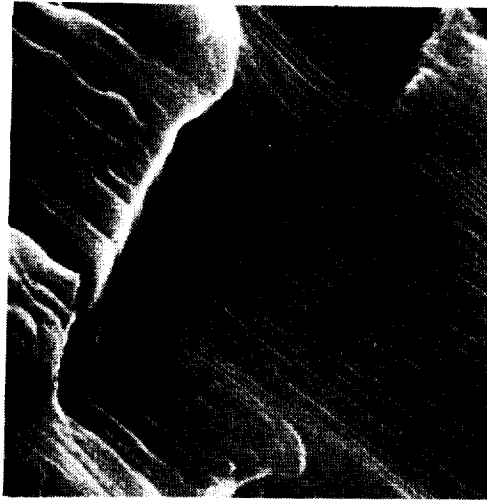
Fig. 5-42  
Region 3. Fatigue striations. 640X

Figures 5-40 to 5-42 Region 3: The striations are evident at this load ratio but the striation spacing is smaller due to the higher R value.
